# YOUR INSPECTION REPORT

95 Candor Hill Road  
Candor, NY 13743

Wednesday, February 6, 2013

RE: Report No. 1003, v.4  
95 Candor Hill Road  
Candor, NY  
13743

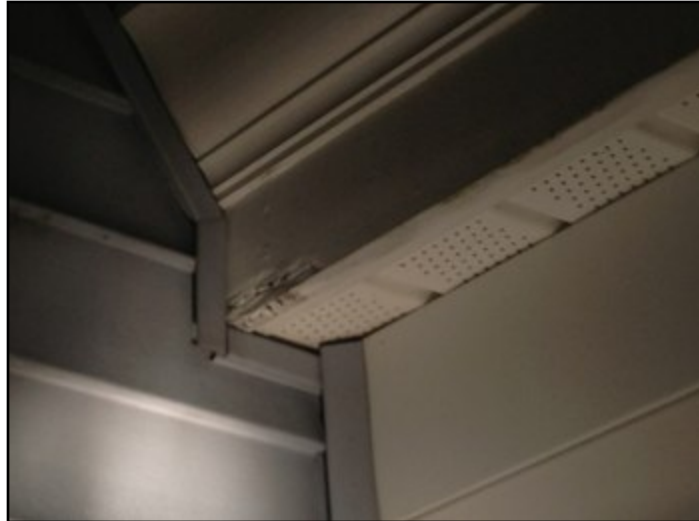
1. No gutters or downspouts

Decayed wood due to missing gutters.

Install gutters to prevent future water intrusion in walls and basement, and front porch.

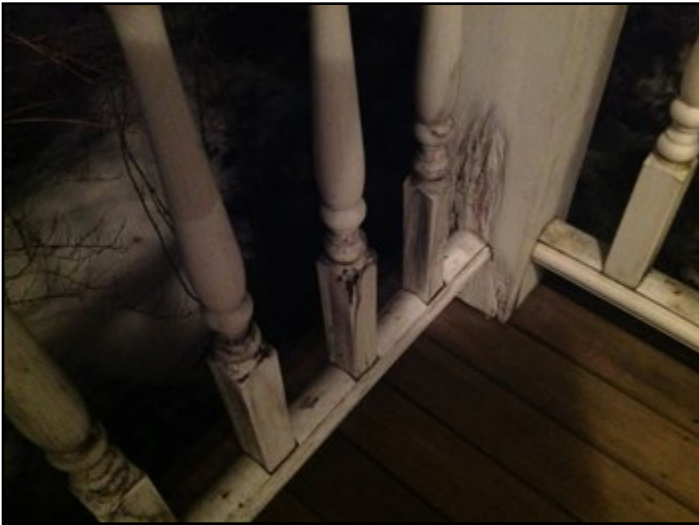
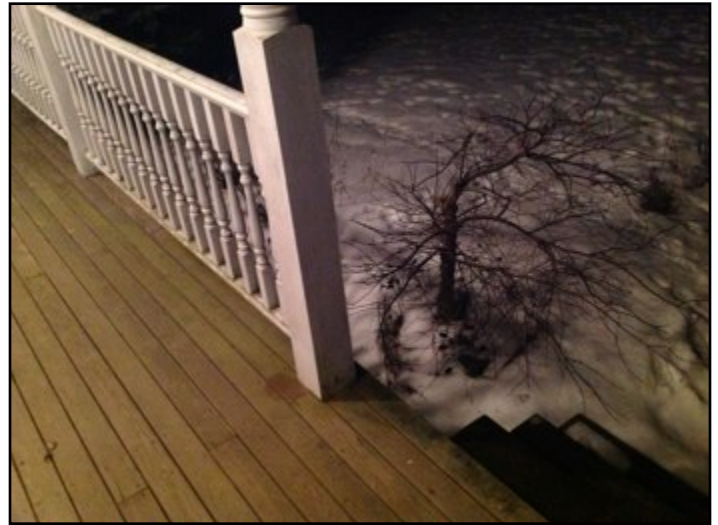
2. Pressure-treated wood

Front porch has no railing along the stairs.

Balusters are rotted and should be repaired or replaced. Rain gutters will help keep moisture out of this area.

Railings decaying on the north and west sides. Need to be repaired by a qualified professional.

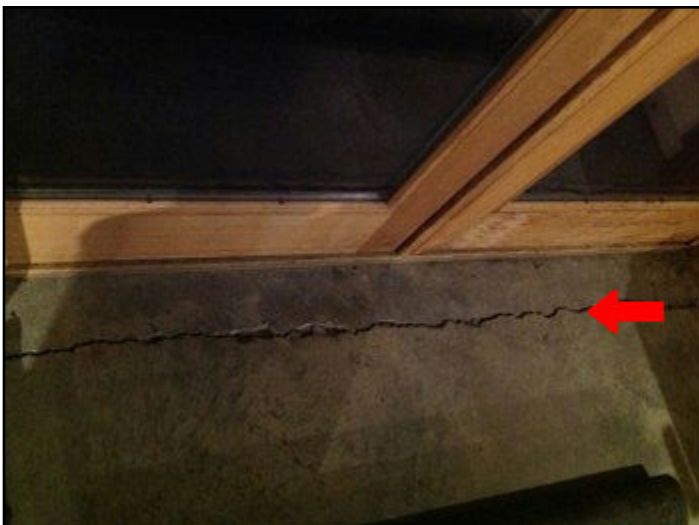
5. Concrete

- [Concrete](#)  
Major crack in floor near basement entrance door. Minor cracks near the pool table in the center of the floor. Recommend repair with concrete caulk.

Floor is cracked by the basement walk-out entrance. Seal with floor caulk, and watch for further movement.
