# YOUR INSPECTION REPORT

95 Candor Hill Road  
Candor, NY 13743

Wednesday, February 6, 2013

RE: Report No. 1003, v.4  
95 Candor Hill Road  
Candor, NY  
13743

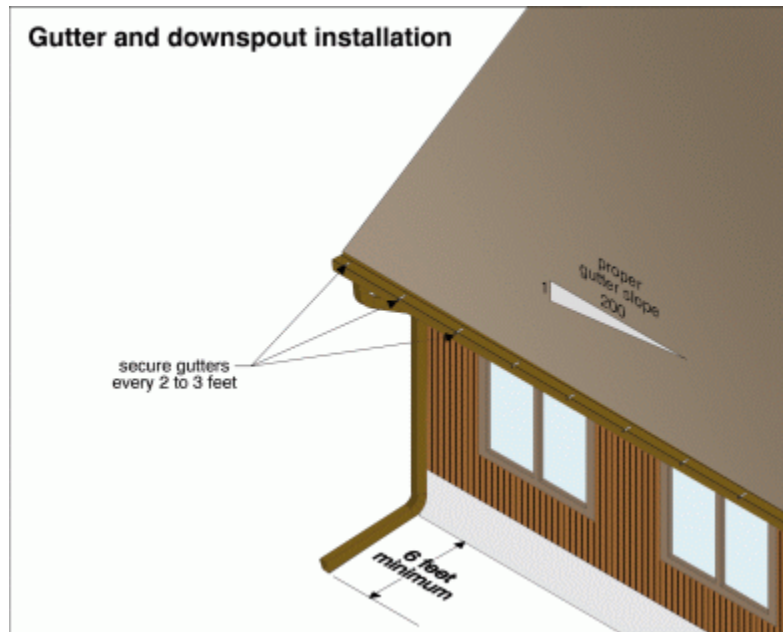
1. Condition: • [Missing](#)

**Implication(s):** Chance of water damage to contents, finishes and/or structure

**Time:** Discretionary

**Cost:** \$1,000 - \$4,000

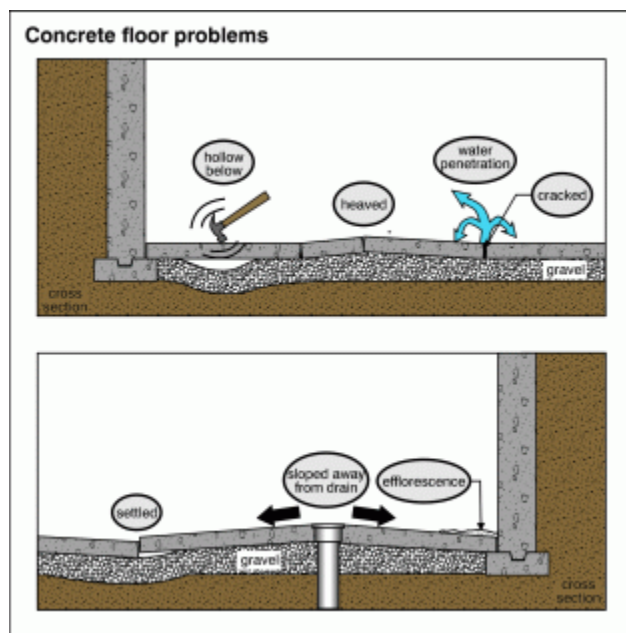
4. Condition: • [Cracked](#)

Floor is cracked by the basement walk-out entrance. Seal with floor caulk, and watch for further movement.

Task: Repair

Time: Discretionary

Cost: Minor

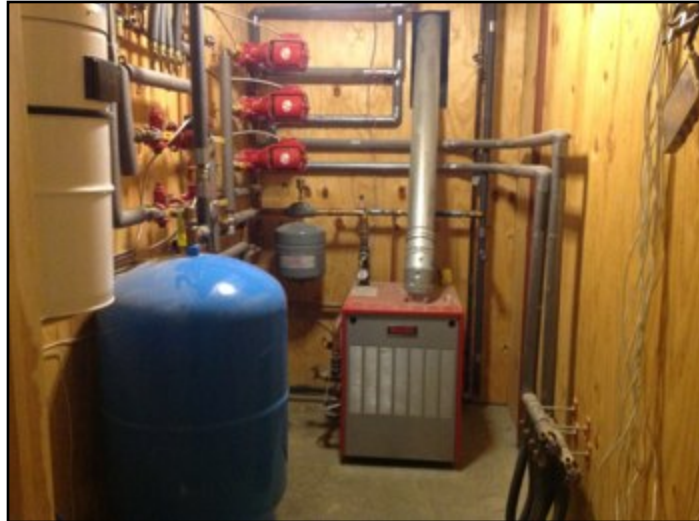
8.

**System type:** • [Boiler](#)

**Boiler manufacturer:** • Smith

**Heat distribution:** • In floor hydronic radiant heat.

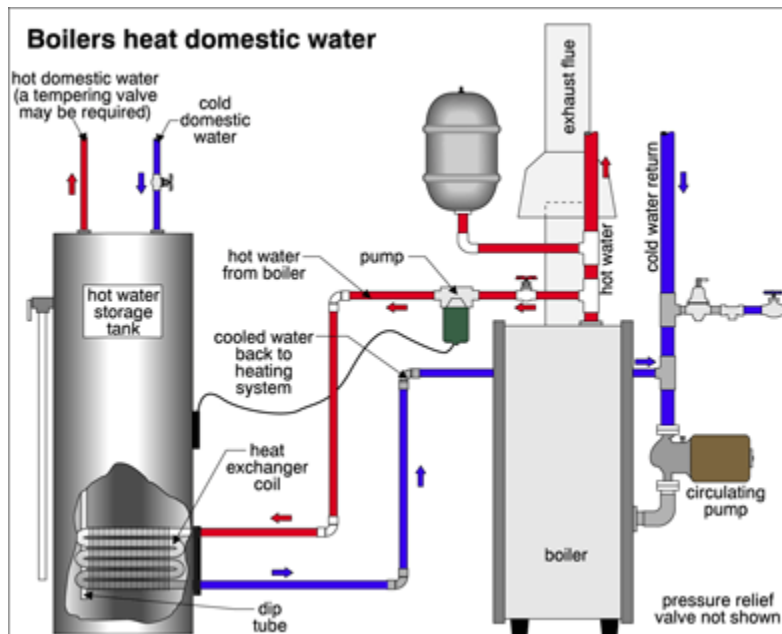
**Water heater type:**

- [Tankless/indirect](#)

**Tank capacity:** • 50 gallons

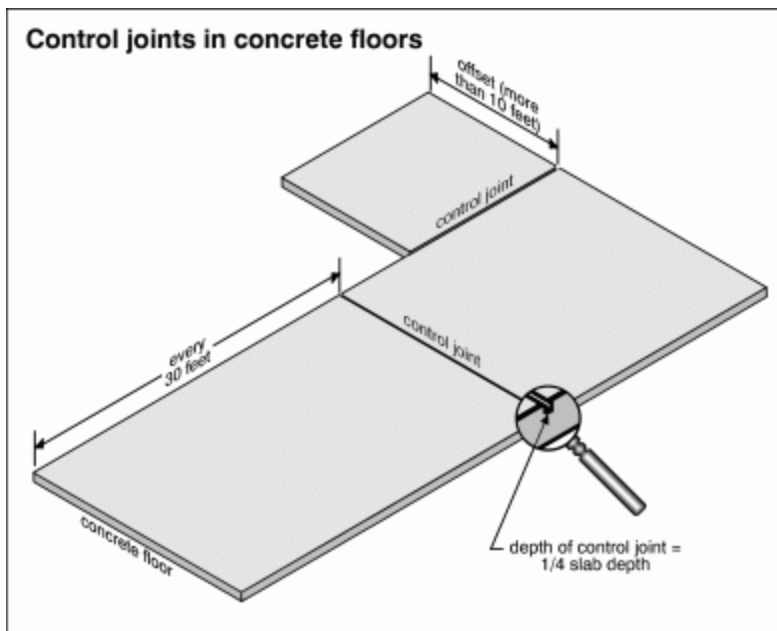
7. Condition: • [Cracked](#)

Implication(s): Cosmetic defects | Trip or fall hazard | Difficult access

Task: Repair

Time: Immediate

Cost: Less than \$100 - \$200
